Contaminated Aircraft Takeoff Tests for the 1998-99 Winter

Transportation Development Centre
On behalf of
Civil Aviation
Transport Canada

October 1999

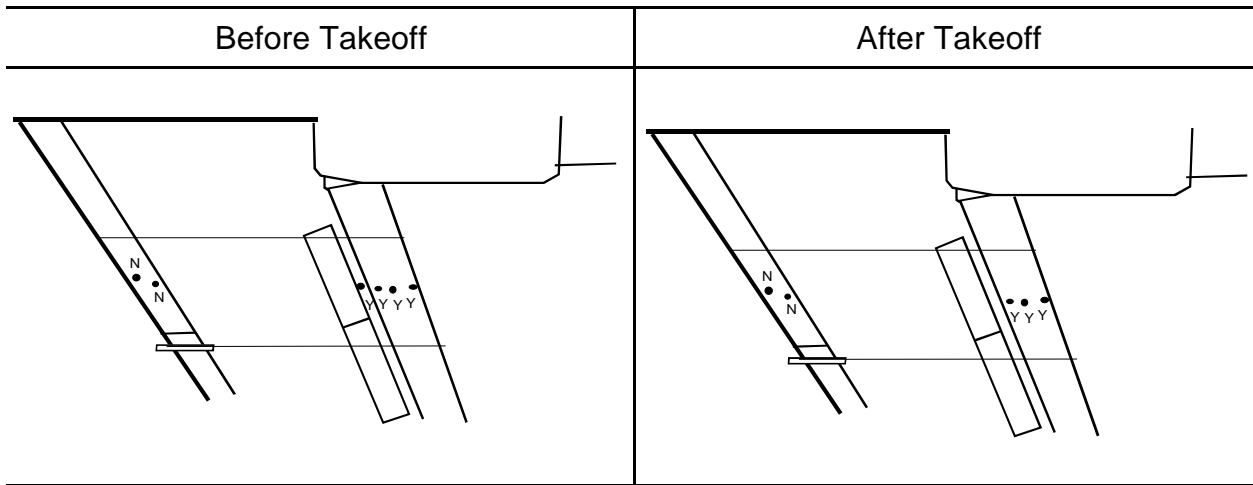
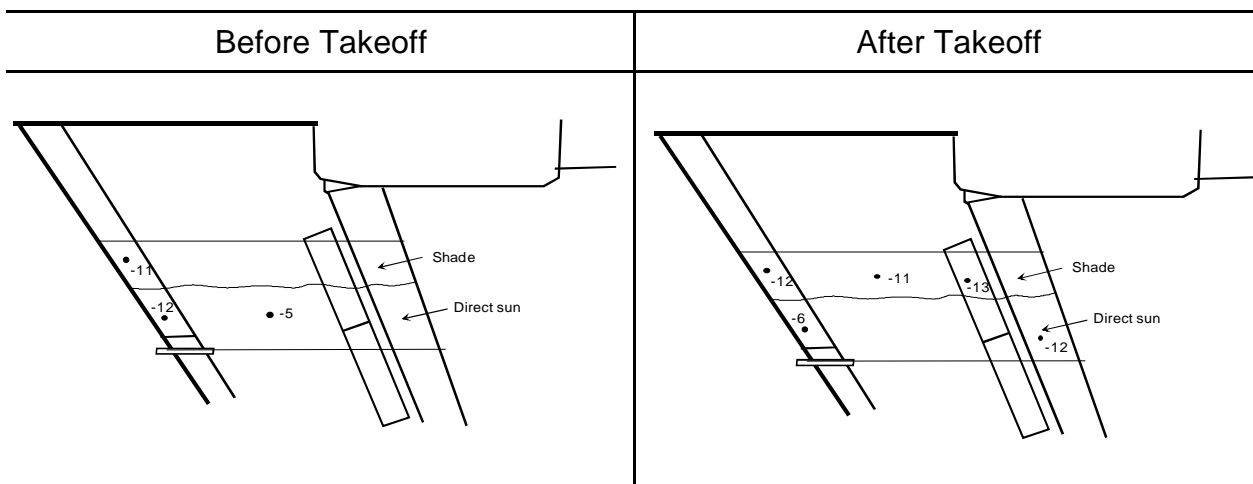
FIGURE 4.5

Run 2 - Failure Pattern After Takeoff Run

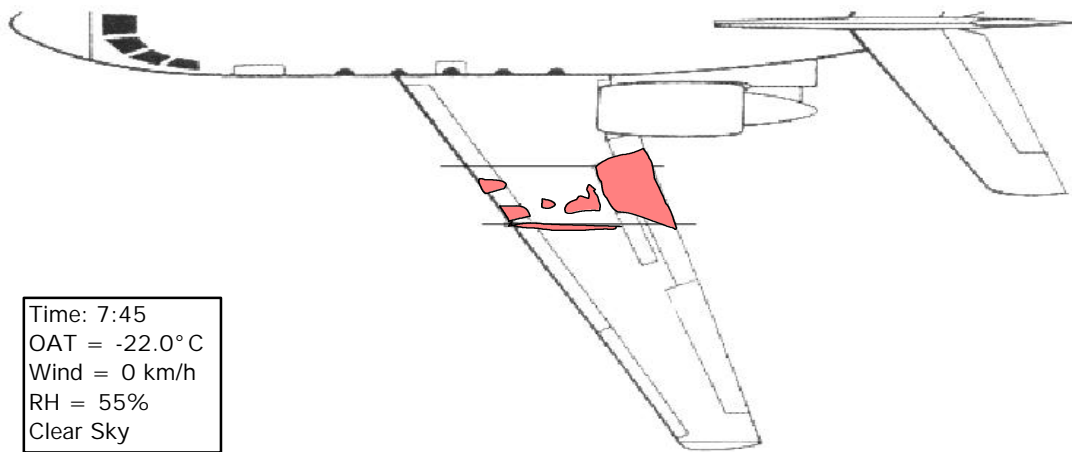
Run 6 - Failure Pattern Before Takeoff Run

Ice patches appeared both on the leading edge and on the rear of the wing, with only small amounts on the mid-wing portion of the test surface. Icy patches on the leading edge were noted to be thicker than elsewhere on the wing.

The experienced cabin observer noted an icy area very similar to that recorded by the ground observer. A slightly smaller icy area was noted on the leading edge.

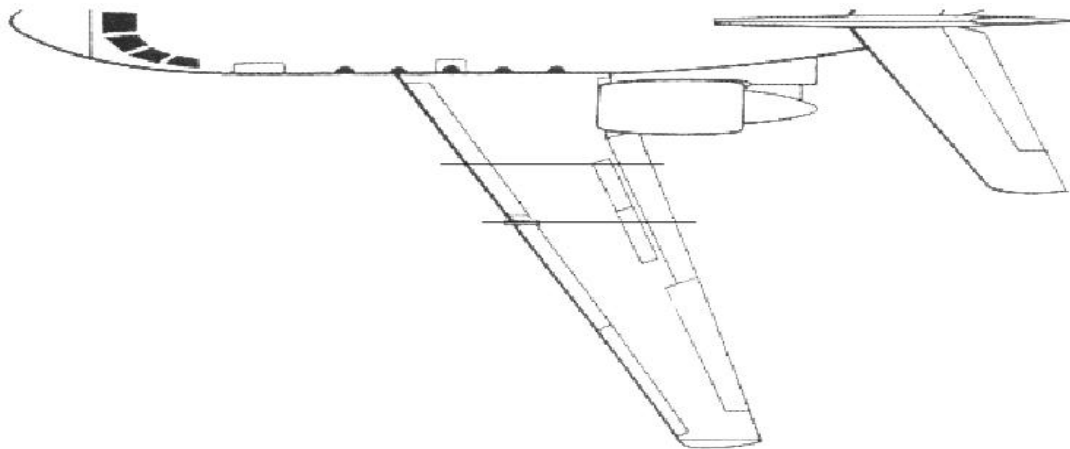
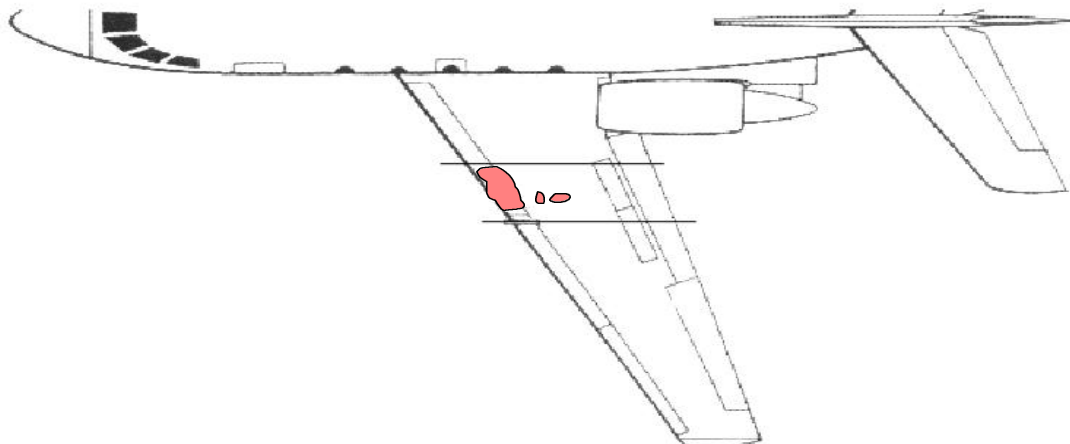
Run 7 - Failure Pattern Before Takeoff Run

The experienced cabin observer noted that the fluid appeared to be slushy but that no ice was distinguishable. No failure pattern was recorded.

The pilot indicated that ice had formed on the leading edge with patches farther back on the main wing. The pilot noted that the appearance of the fluid was not similar to previous runs.

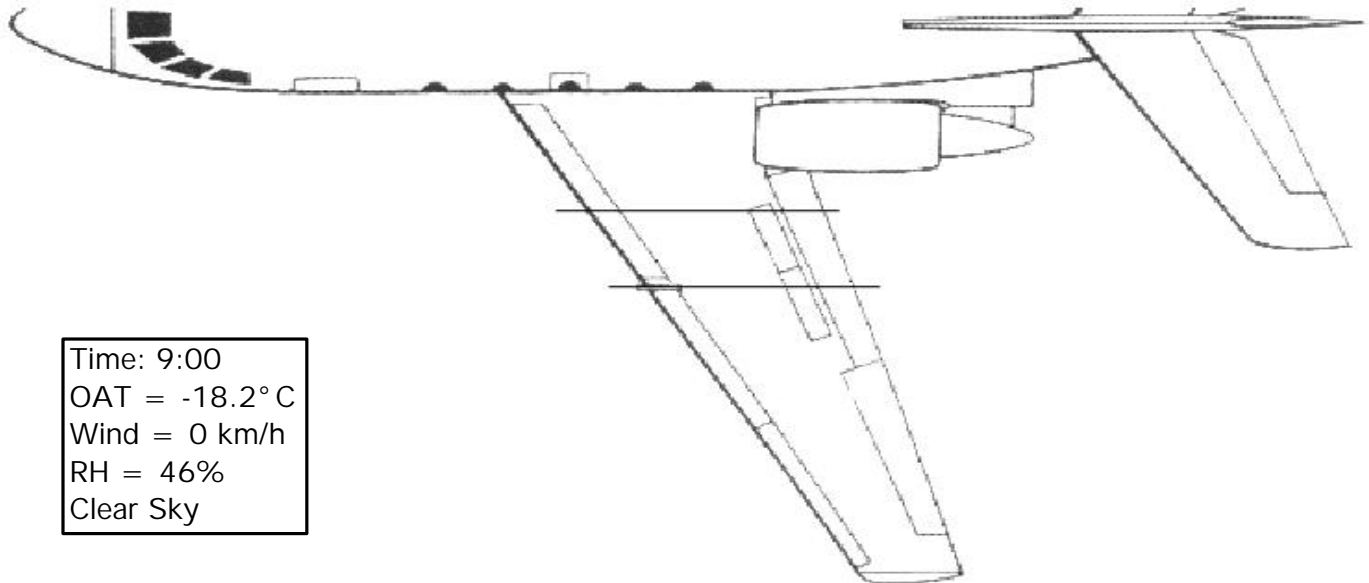
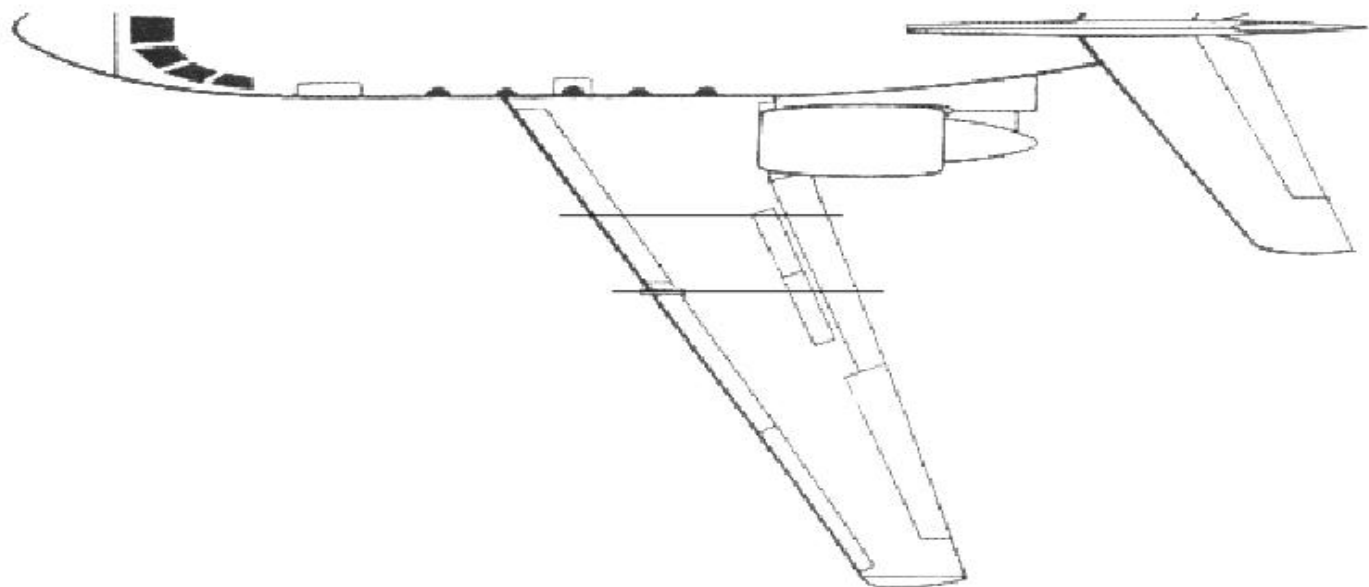
Run 7 - Failure Pattern After Takeoff Run

On return from the takeoff run, it was observed that the entire fluid layer had been eliminated from the wing (Figure 4.22). The results are similar to those of Run 4, which also employed the propylene glycol-based fluid, but with no contamination. No solids remained, and any fluid that remained on the wing took on the appearance of lateral ridges running perpendicular to the wing chord. Photo 4.14 shows the clean wing following the takeoff run.

The observer noted that the wing was clean and that the slush had been sheared off completely and rather spectacularly during the takeoff run.

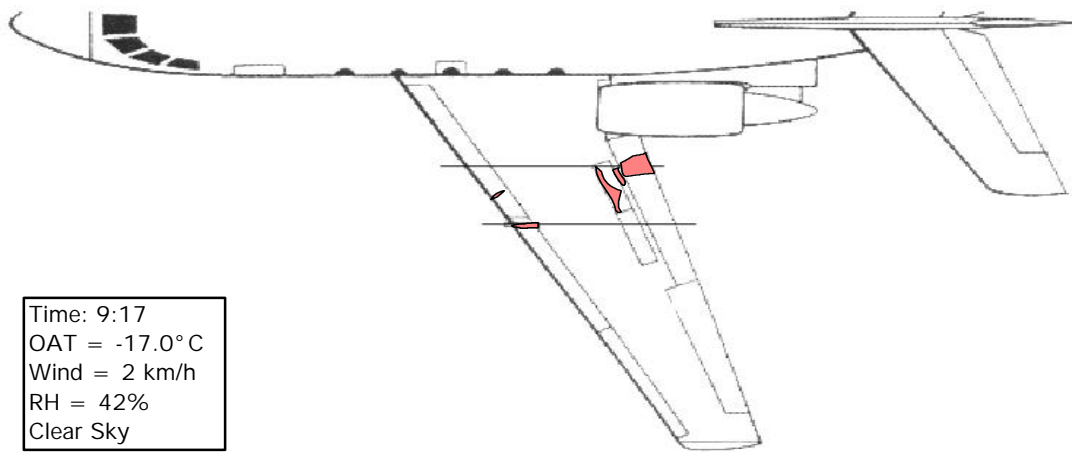
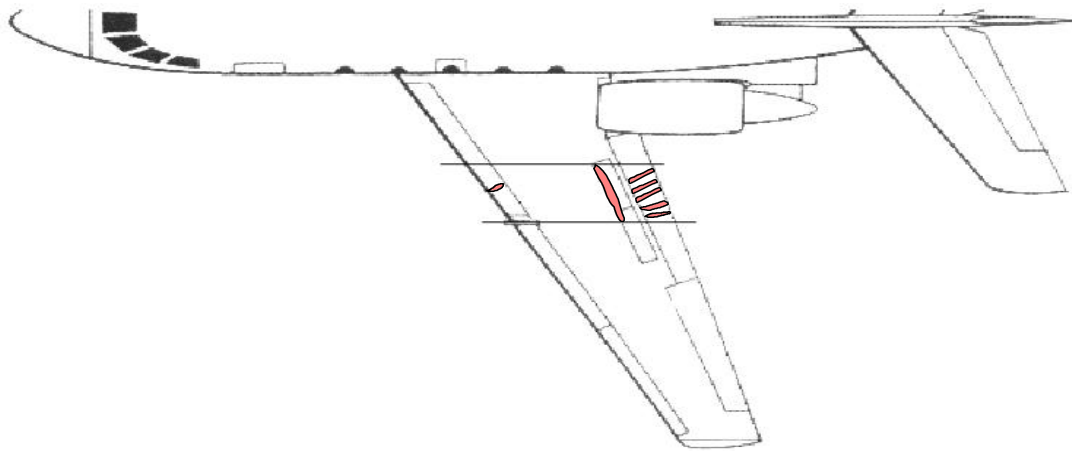
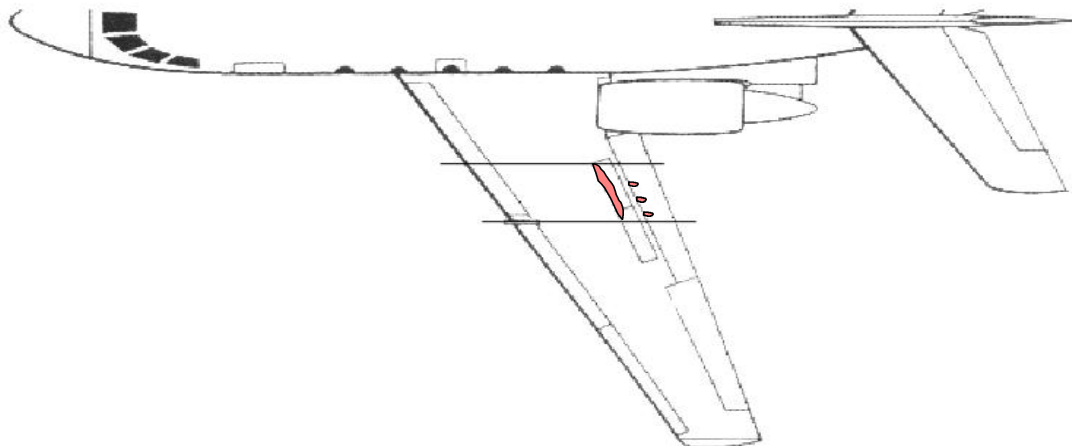
Run 8 - Failure Pattern Before Takeoff Run

A small ice patch (Figure 4.23 and Photo 4.15) appeared on the leading edge and slightly larger patches were observed on the spoiler panel and on the flap. The wing observer noted that flow off from the top of the main wing eroded the fluid in these areas, leading to failures. The iced area on the leading edge was located at a seam in the leading edge structure. This area had also been the site of initial failures in previous tests.

The experienced cabin observer noted the patch of ice on the leading edge and on the spoiler panel.

The pilot noted the existence of an ice patch on the spoiler panel and some on the flap, but did not identify the small area on the leading edge.

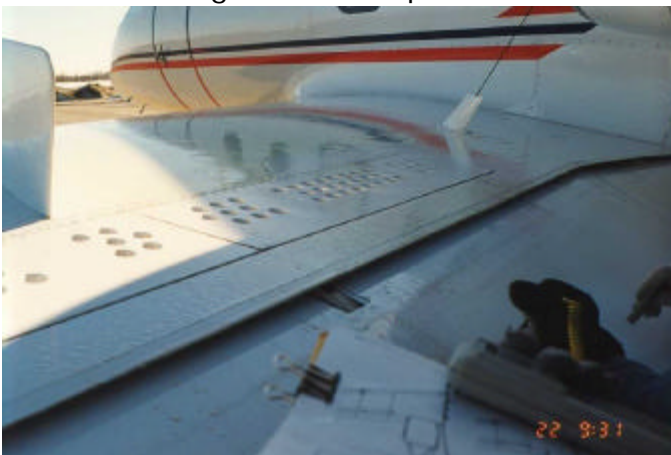
Photo Set 4.2
Run 1 - Appearance of Fluid Following Takeoff Run

Thin Film on Leading Edge

Film on Rear of Wing

Puddling Ahead of Spoiler Panel

Fluid Ahead of Spoiler Panel

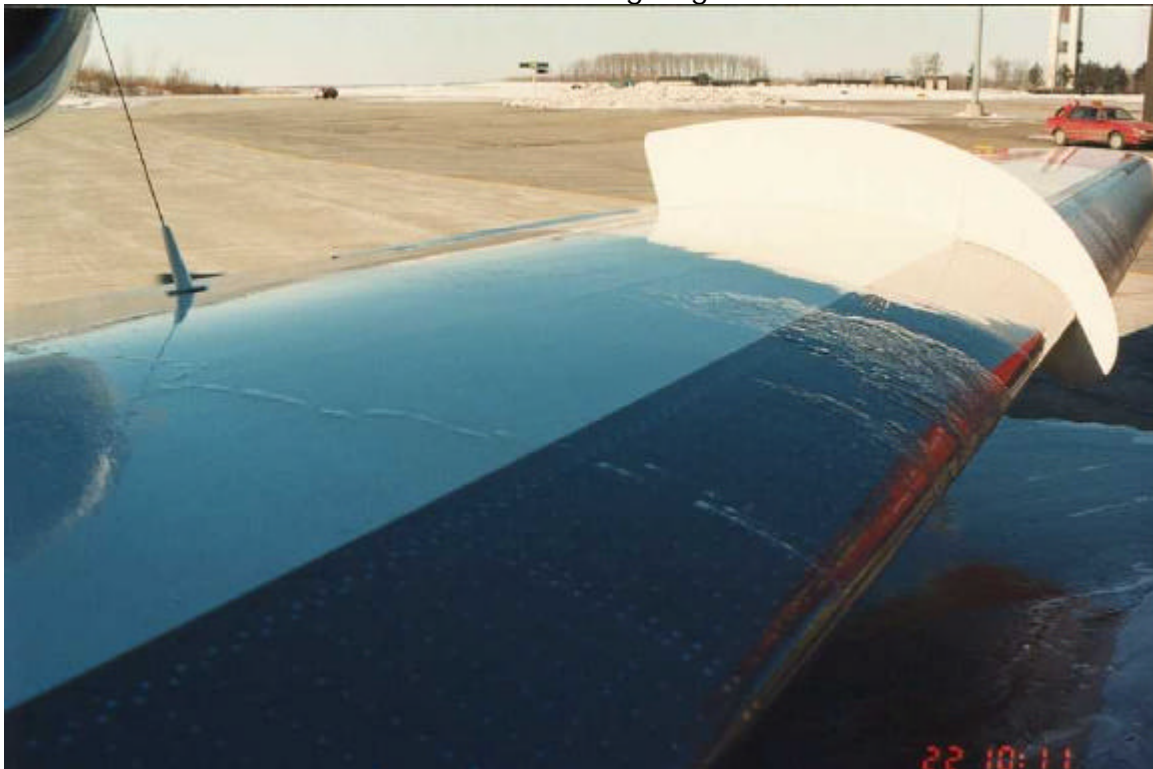
Photo Set 4.3
Run 2 - Appearance of Fluid Prior to Takeoff Run
Ethylene Glycol-Based Type IV Fluid at 25 Percent Contamination
Failed Fluid on Flap

Ice on Leading Edge

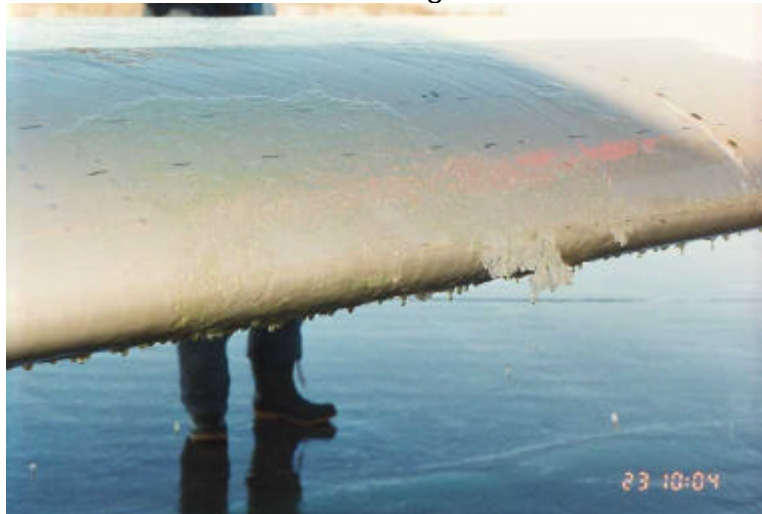
Photo Set 4.17
Run 9 - Appearance of Fluid Prior to Takeoff Run
Propylene Glycol-Based Type IV Fluid at 100 Percent Contamination
Ice Crust Sliding Forward

Ice Crust on Rear Wing

Ice Formation on Leading Edge
